Engine 'Core Lock-up' Phenomenon

15 December 2004

BOMBARDIER

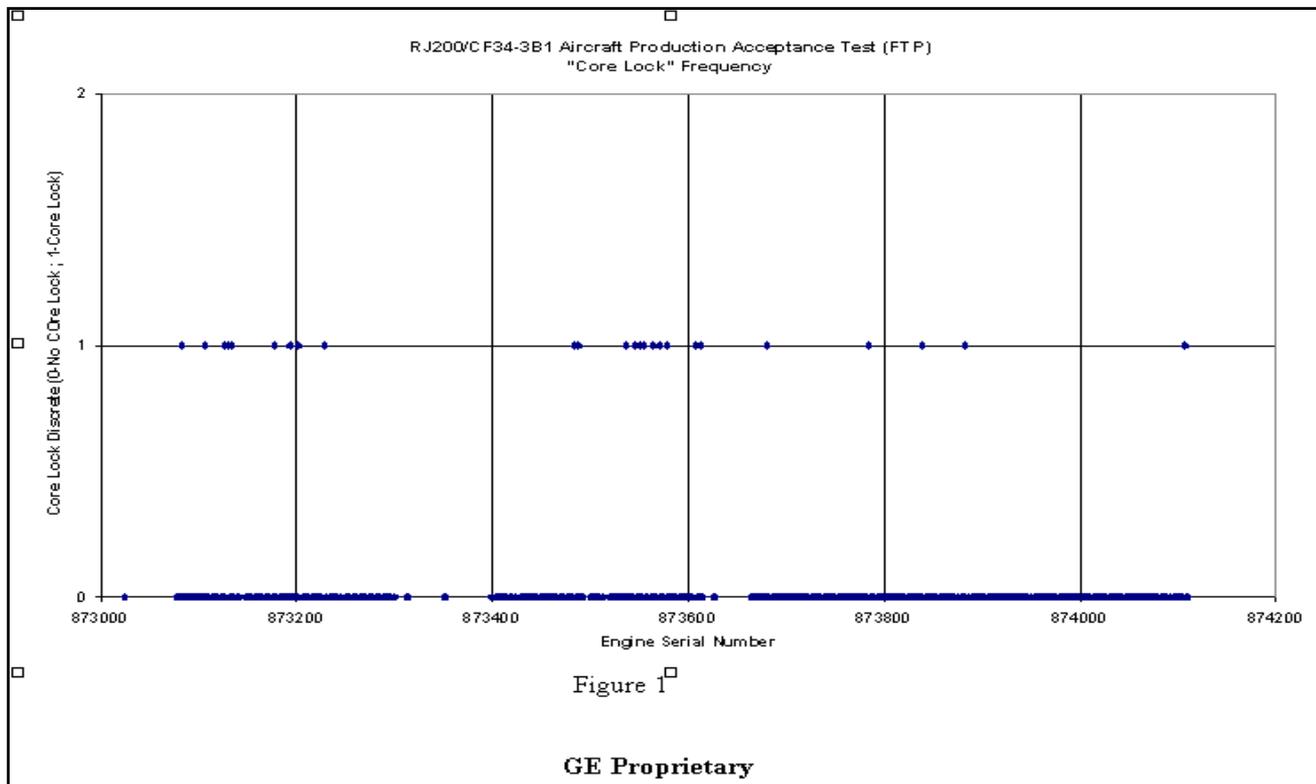
- Core lock up current rate, ~1.5% based on a sample of 669 engines tested between March 2001 and September 2004. 27 engines required the break-in in procedure.

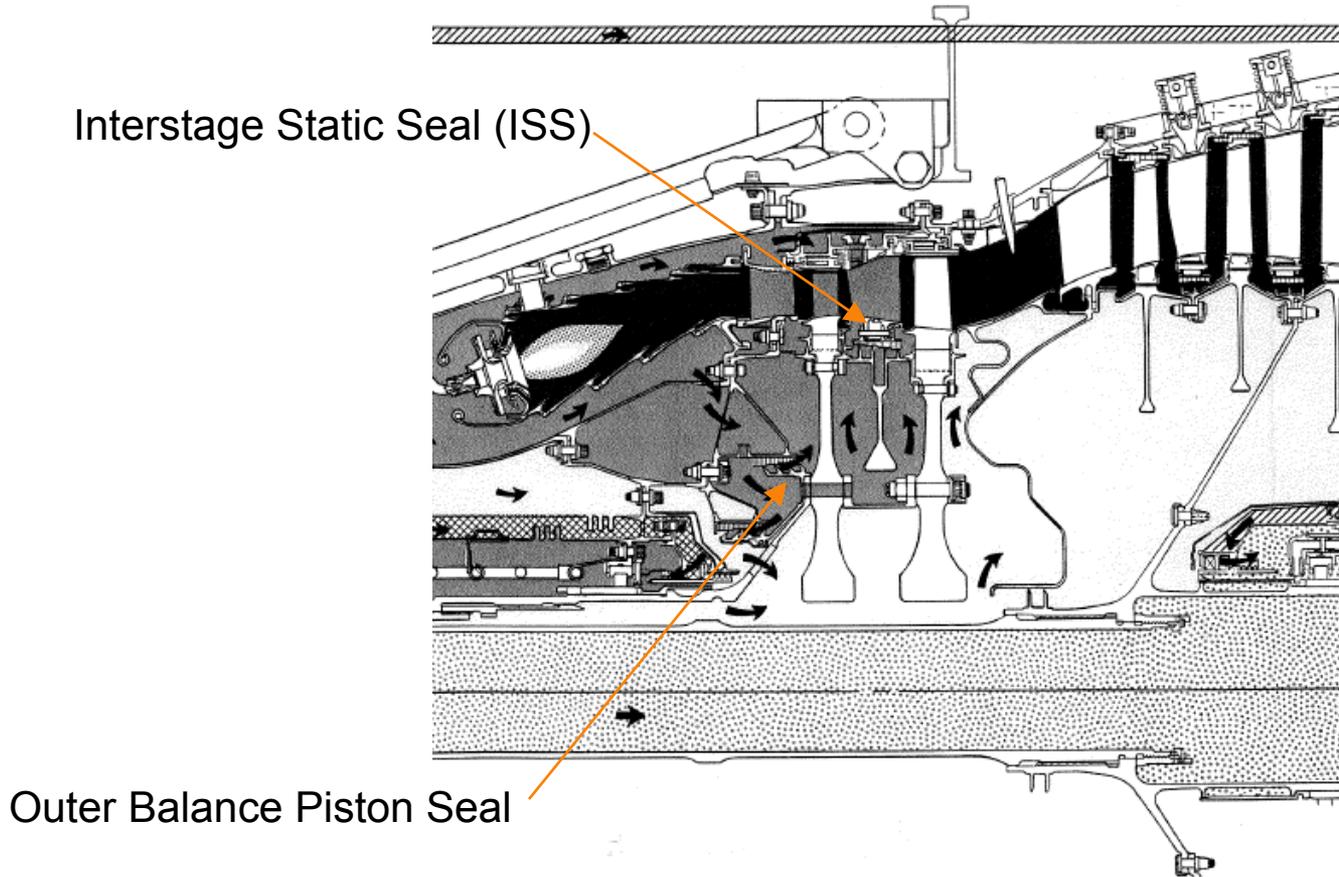
CF34 support illustrations

- **The CF34-3 engine series on Bombardier aircraft has had 2 areas suspected of causing core lock-up.**
 - Outer Balance Piston Seal: This area was suspect during initial CRJ certification, as noted within the Ops Test report. Design changes were implemented but no significant improvement was observed.
 - Inter-Stage Seal: This area was later determined to be a contributor. A design change was implemented (~1994) and the resultant lock-up phenomenon was substantially improved (~ 20% reduced to 1.5%)
